# **WATER/MOISTURE IN COP WELLS—DTC P0301-P0308—3.9L ENGINE—VEHICLES BUILT THROUGH 5/1/2004**

**TSB 05-16-2**

2002-2005 Thunderbird

2000-2005 LS

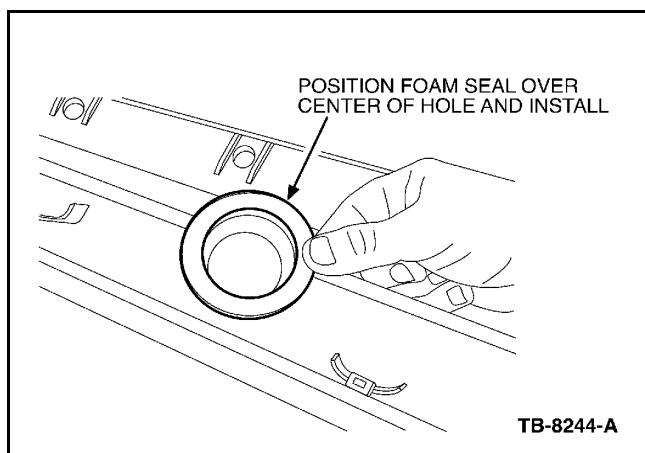
Figure 1 - Article 05-16-2

Some 2000-2005 Lincoln LS and 2002-2005 Thunderbird vehicles equipped with the 3.9L engine and built through 5/1/2004, may exhibit a misfire condition and possible diagnostic trouble codes (DTCs) P0301-P0308. This may be caused by water or moisture in the coil on plug (COP) and coil wells, due to water leaking past the foam seal of the cowl panel grill.

1. Remove the cowl panel grille refer to section 501-02 of the 2005 Lincoln LS Workshop Manual.
2. Remove the foam seal and discard (Figure 1).
3. Clean foam-sealing area using Bug and Tar Remover (ZC-42) or equivalent.
4. Install a new foam seal (5W4Z-54021A46-A), centering the seal on the hole of the cowl panel grille (Figure 1).
